DEPARTMENT OF TRANSPORTATION

Contract #: 04-0120F4Cty: SF/ALA Rte: 80 PM: 13.2/13.9File #: 1.28**WELDING INSPECTION REPORT****Resident Engineer:** Casey, William**Address:** 333 Burma Road**City:** Oakland, CA 94607**Report No:** WIR-029528**Date Inspected:** 23-Mar-2013**Project Name:** SAS Superstructure**OSM Arrival Time:** 700**Prime Contractor:** American Bridge/Fluor Enterprises, a JV**OSM Departure Time:** 1530**Contractor:** American Bridge/Fluor Enterprises, a JV**Location:** Jobsite**CWI Name:** See below**CWI Present:** Yes No**Inspected CWI report:** Yes No N/A**Rod Oven in Use:** Yes No N/A**Electrode to specification:** Yes No N/A**Weld Procedures Followed:** Yes No N/A**Qualified Welders:** Yes No N/A**Verified Joint Fit-up:** Yes No N/A**Approved Drawings:** Yes No N/A**Approved WPS:** Yes No N/A**Delayed / Cancelled:** Yes No N/A**Bridge No:** 34-0006**Component:** OBG**Summary of Items Observed:**

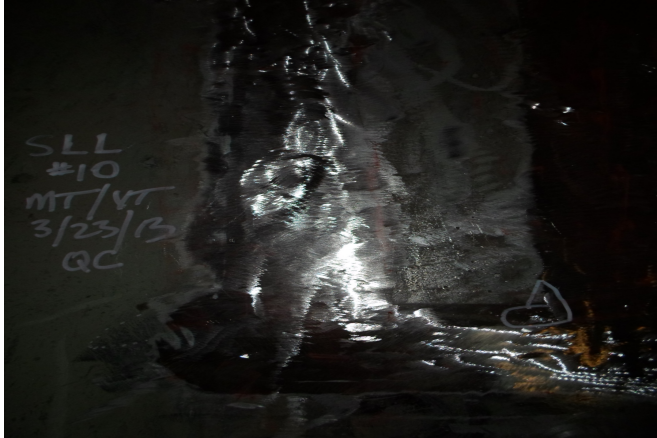
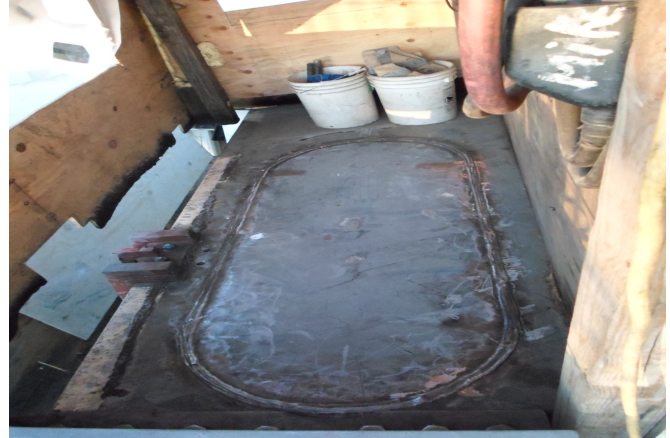
This QAI witnessed the Quality Control (QC) Inspector William Sherwood perform the Magnetic Particle Testing (MPT) of the lifting rod closure plate weld identified as EB-SLLH-10 and the adjacent lifting lug removal areas of the longitudinal shear plate identified as EB-SLL-10. This QAI performed the Magnetic Particle (MPT) verification inspections of lifting rod closure plate weld EB-SLLH-10 and the adjacent lifting lug removal areas of the longitudinal shear plate identified as EB-SLL-10. See the attached TL6028 MT report for details. This QAI also performed Ultrasonic Testing/UT of the EB-SLLH-10 lifting rod closure plate weld. See the attached TL6027 UT report for details. The welding and QC inspection was observed and verified by this QAI and appeared to be in compliance with the contract documents.

This QAI witnessed the preheating to 150F and 1G flat position welding completed of Deck Access Hole (DAH) weld 12E-PP116.5-E2 by welder Mike Jimenez #4671 utilizing E7018 4.0mm electrodes at 180 amperes as per WPS 1040C rev 1. The Quality Control (QC) Inspector Salvador Merino was present. The backgouging of the

weld root to sound metal is in progress at this time. The 1G (flat position) portion of welding and QC inspection performed by Sal Merino was observed and verified by this QAI and appeared to be in compliance with the contract documents.

The digital photographs below illustrate some of the work activities observed on this date:
